Enhanced Preliminary Assessment Report:

Monroeville Army Housing Units
Monroeville, Pennsylvania

October 1989

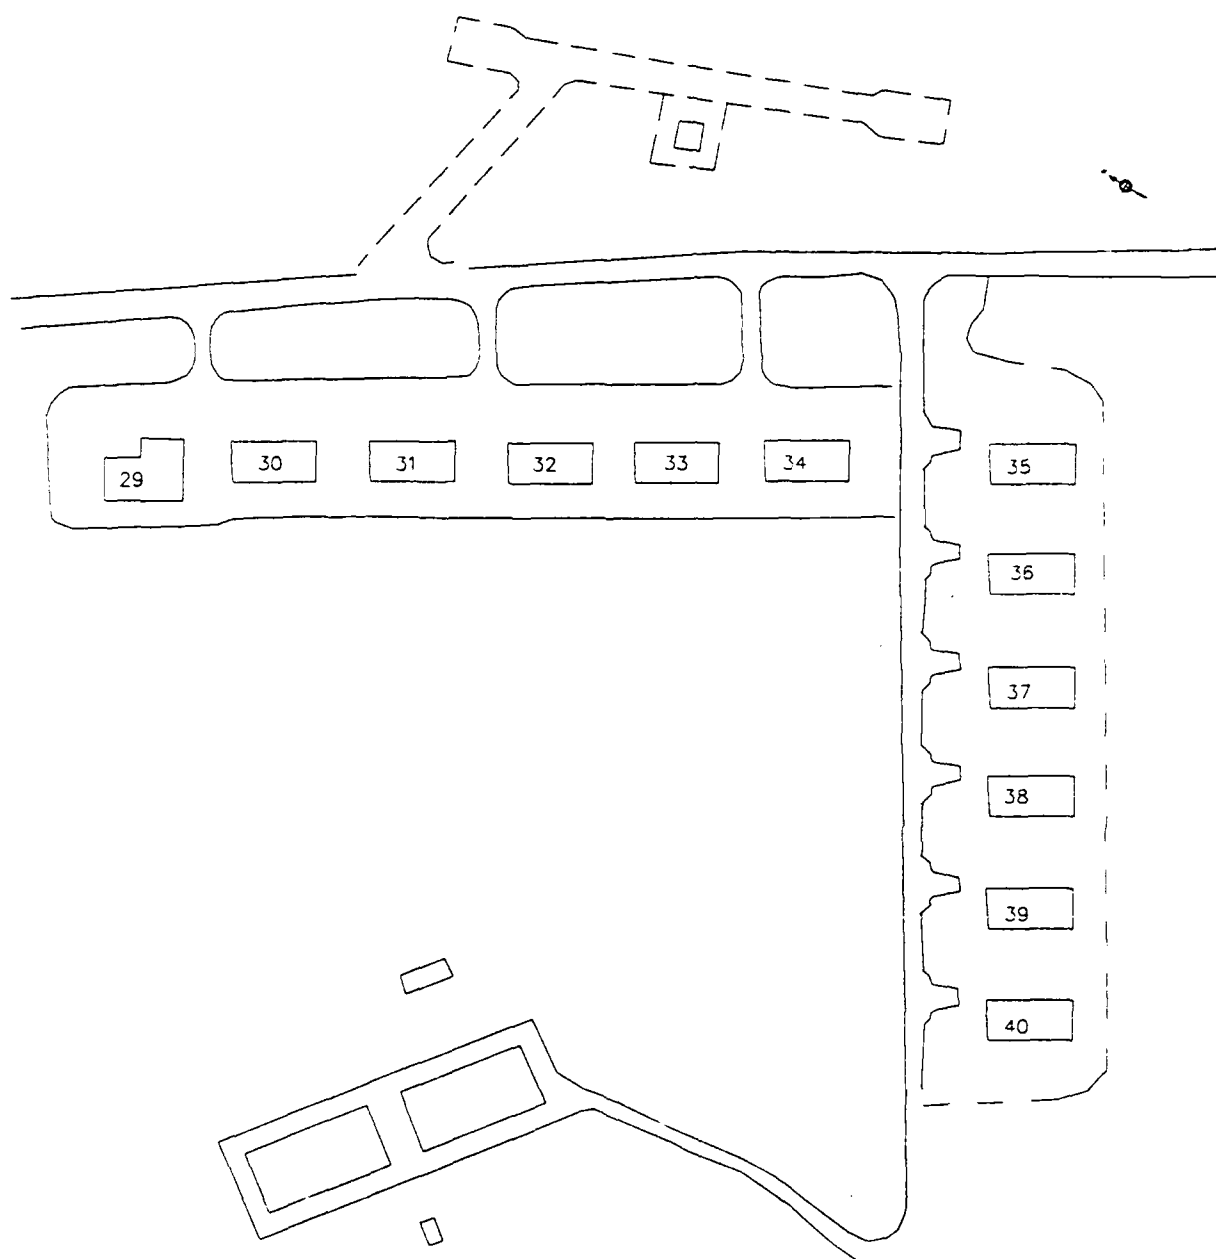
FIGURE 3 Site Plan Map of Monroeville Army Housing Units

The Monroeville family housing site has its own sand-filter sewage-treatment facility, which is maintained and operated for the Army by a local contractor. The sewage treatment plant consists of two parallel sand filters. Half of the plant was completely upgraded early in 1989. However, some work is not yet completed. Specifically, the valving that allows diversion of sewage from one sand filter to the other has not yet been repaired. As a result, sewage cannot be directed to the newly renovated

sand filter. Septic conditions still exist in the old sand-filter beds, which prevents use of the renovated sand filters. The old bed is overgrown with brush and weeds.

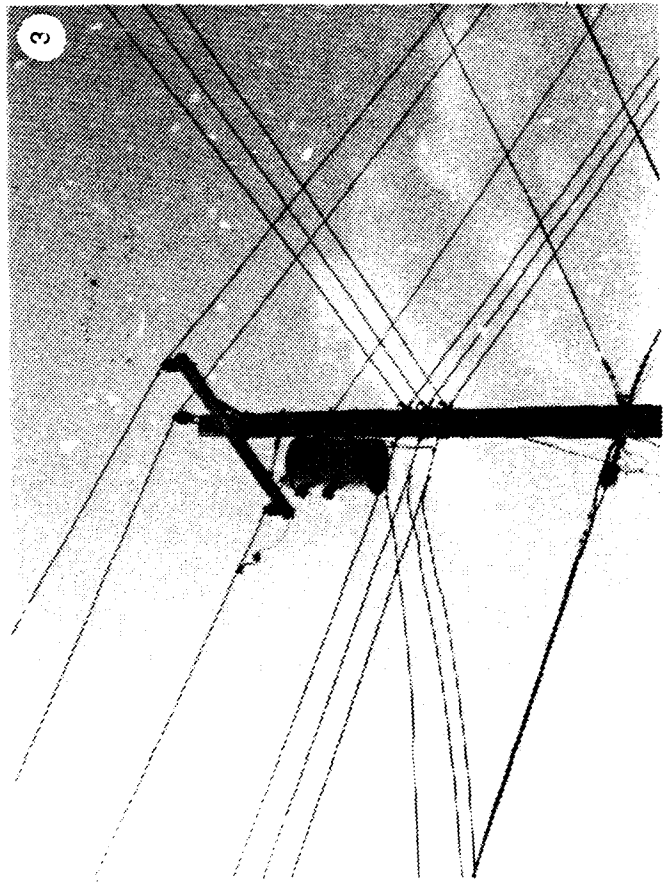
3

1. A row of houses on Lindsey Lane.
2. Grounds at the rear of the housing units.
3. Electrical transformer mounted near the top of the utility pole; the Portland Power Company is responsible for area transformers.
4. The sand-filter bed of the sewage treatment system.
5. Stagnant raw sewage on the top of another sand-filter bed; existing conditions at the sewage-treatment facility are to be corrected.

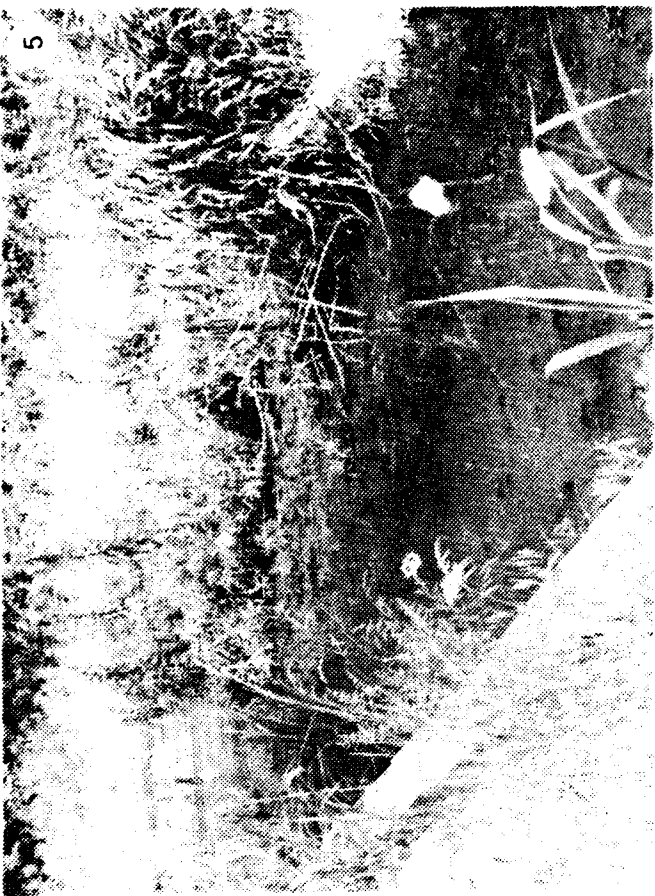
Currently, the newly upgraded sewage treatment facility is not operating properly. Because of an oversight relating to valve operation and other uncompleted work, the newly renovated sand filters cannot be put on line, and sewage continues to be inadequately treated in the old malfunctioning sand filters.

Soil and water sampling should be carried out at the sewage treatment facility to determine environmental impact before this property is sold. Furthermore, this sampling should be designed and conducted in such a way so as to guarantee the absence of Nike missile-related contaminants that could have been previously discharged to the facility from the nearby IFC area. It is further recommended that corrections to the treatment facility to resolve operating problems be made.
